## Natchez Bluff

Natchez, Mississippi

### *Keystone Saves Historic Homes From Failing Bluffs*

32' High Keystone Wall solves the historic “Natchez Bluff” problem!

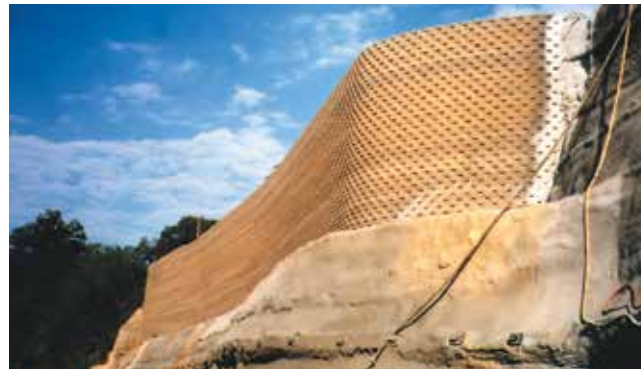
View of wall with soil nailed "bench" below.

shelf 25' out toward the river from the stabilized wall. The section above this bench was cut back 10' (3.0 m) and the remaining area was stabilized with geogrid soil reinforcement and filled with 6,000 pounds of lightweight aggregate, topped with sod and plants. One sidewall of the section is the original bluff, and the back wall of the section is the shotcrete-covered soil-nailed wall.

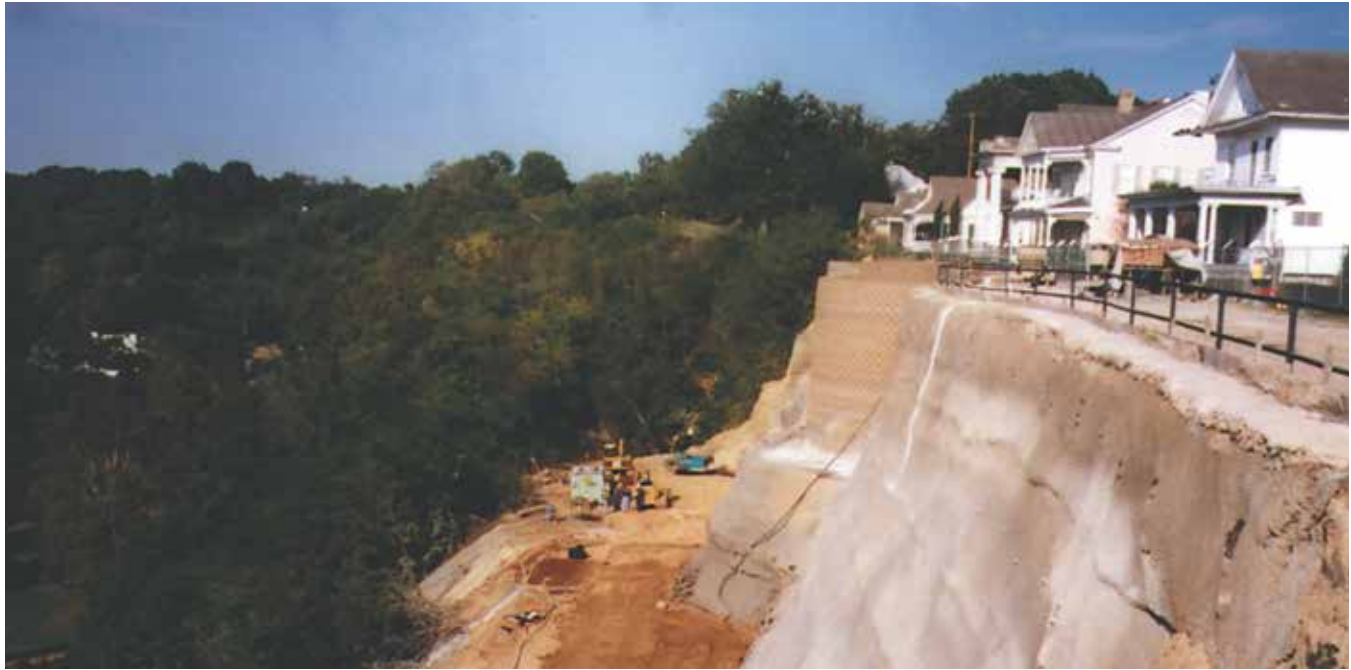
The top of the Keystone wall provides new front yards for bluff homeowners.
