## The Metropolitan Plant Exchange Fort Lee, New Jersey

<b>Project:</b>	<i>The Metropolitan Plant Exchange</i>
<b>Location:</b>	<i>Fort Lee, New Jersey</i>
<b>Keystone Product:</b>	<i>Keystone Compac™ Victorian</i>
<b>Licensed Manufacturer:</b>	<i>Anchor Concrete Products Manasquan, New Jersey</i>
<b>Total Wall Area:</b>	<i>11,923 square feet</i>
<b>Wall Contractor:</b>	<i>Pillari, LLC</i>
<b>General Contractor:</b>	<i>J.Fletcher Creamer &amp; Son, Inc.</i>
<b>Wall Engineer:</b>	<i>Keystone Engineering</i>
<b>Site/Civil Engineer:</b>	<i>Costa Engineering</i>
<b>Geotechnical Engineer:</b>	<i>Melick-Tully Associates</i>
<b>Surveyor:</b>	<i>Creamer Engineering Services</i>

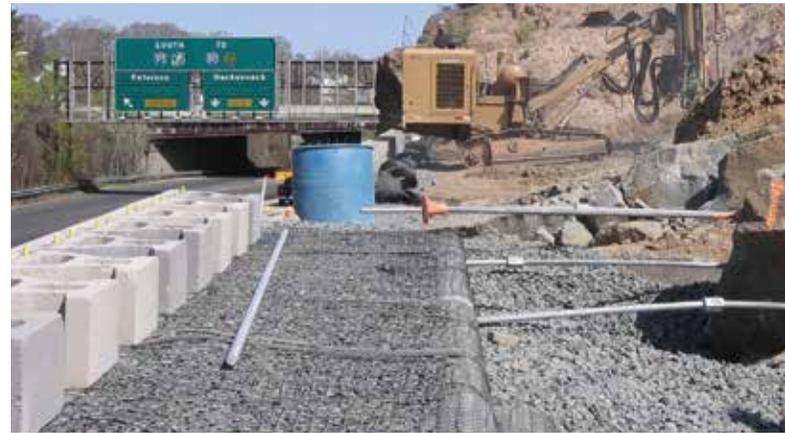
The weaker bedrock was removed in a non-benched excavation by drilling, splitting and hammering. The excavation of the established non-competent bedrock produced gaps along the wall's base which were filled with crushed stone. Excavation efforts also included establishing the retaining wall's leveling pad and drilling holes for rock dowel placement. After the dowels were placed, the concrete leveling pad was poured and pinned to the bedrock and the first course of the wall was pinned and grouted to the leveling pad.

The presence of bedrock in many sections of the wall's reinforced zone prevented some geogrid from being placed at its required length. Rock anchors were used in these areas. More than 200 rock anchors were used at various elevations at the base of the wall. Some anchors were placed up to eight feet high on the wall. A five-inch diameter galvanized schedule 40 steel spreader pipe was drilled and fastened to the rock anchors.
