Stoney Beach

Baltimore, Maryland

Walls Protect Development From Flood Waters

CASE STUDY

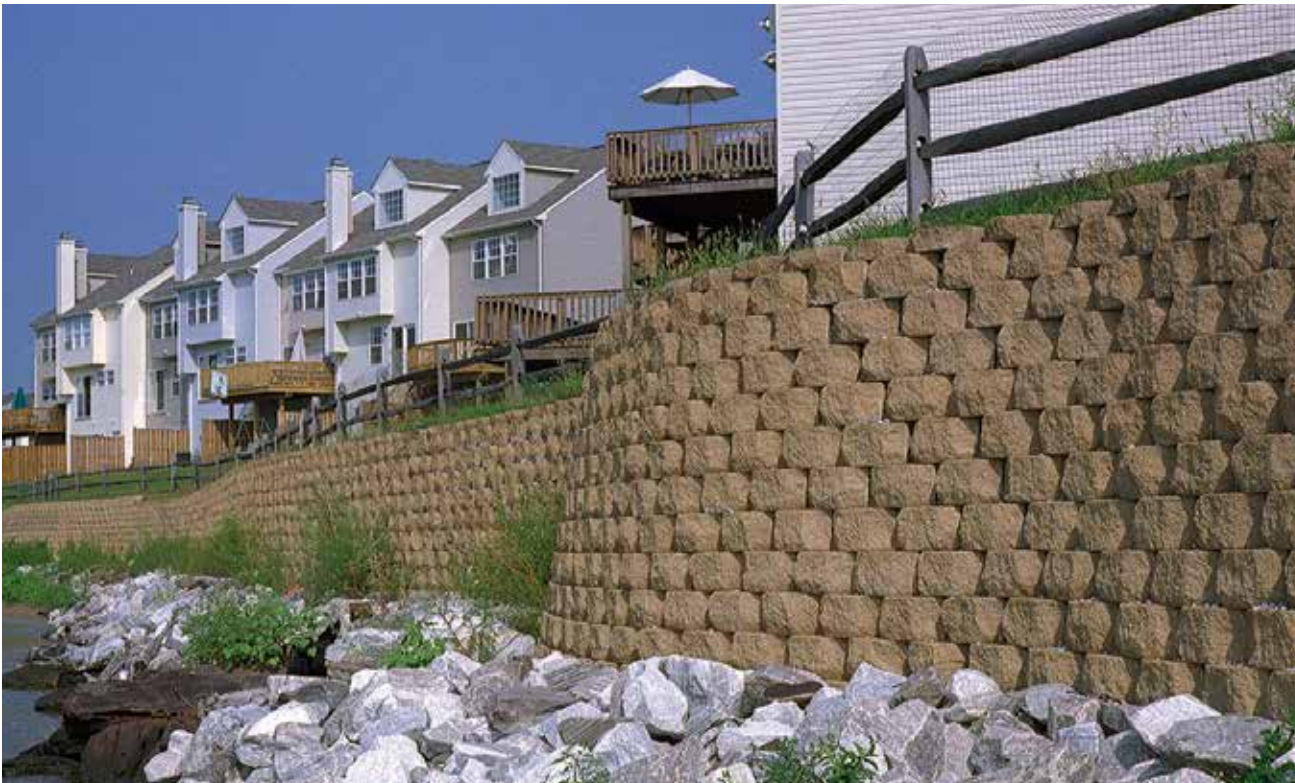
Keystone walls offer an aesthetically pleasing solution at Stoney Beach while providing stability to the shoreline.

The 8,400 square foot wall is 900 feet (274m) long with maximum wall heights of nine feet (2.7m). Keystone Standard Units with the tri-plane rockface texture were used on the project. They were placed on 3 feet (0.9m) of compacted 3/4" (20mm) gravel to overcome a soft base sub-soil condition. The project used approximately 3,000 square yards of Mirafi 5T & 7T with embedment lengths between 9 and 10.5 feet (0.9 - 3.2m). The wall design also called for four feet (1.2m) of free draining gravel behind the wall to provide release of hydrostatic pressures caused by flooding. 700 tons (635,000 kg) of armor stone (rip-rap) was placed in front of the wall to stop the water from eroding the base of the wall.

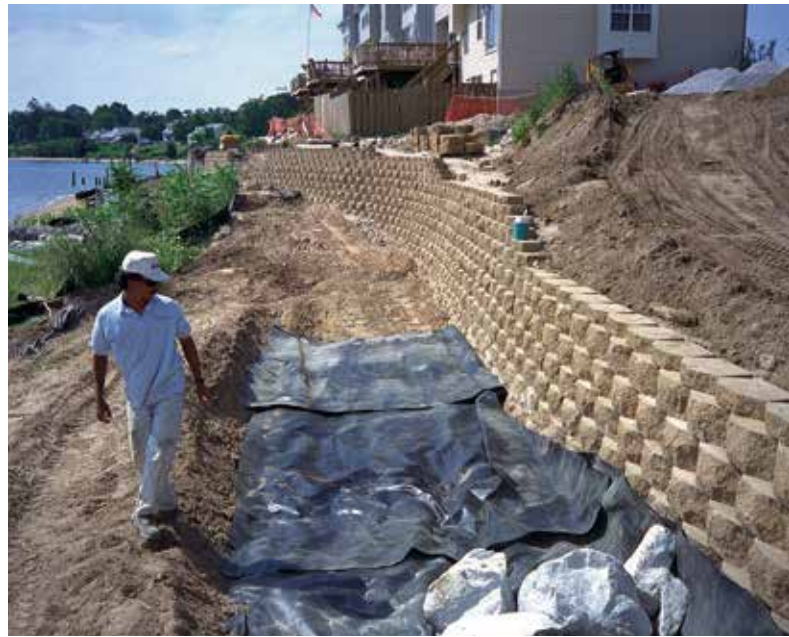
Installing the rip-rap at the base of wall

The wall was put to the test the following winter of 1995/96 when flood water crested nearly half way up its face. Some of the beach was lost but the Keystone wall and rip-rap remained in place as a testimony to the durability of the product and system!
