Olympic Stadium

Homebush Bay, Australia

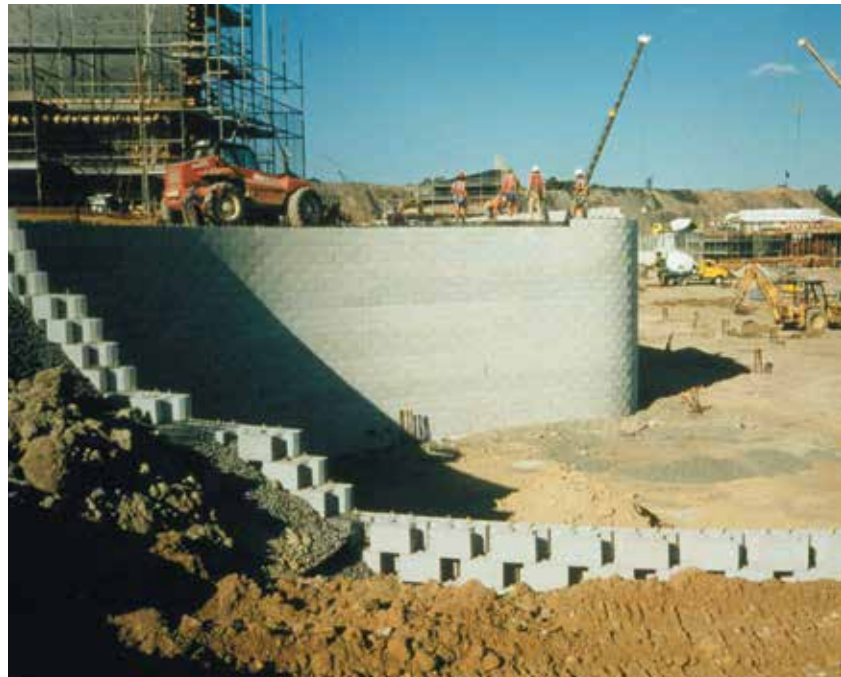
High quality results using smooth texture Keystone units and multiple radii layout.

The corduroy textured Keystone Unit was originally proposed, however, OCA was concerned that the rough surface of the block would be difficult to keep clean and asked Multiplex to find an alternate texture solution. Boral offered a custom-made smooth face block that included the original modifications to meet the fire tests.

Many challenges arose from the change in face texture. The smooth face of the block is more susceptible to chipping than a split-face or corduroy texture unit, which meant that 15% of the custom made blocks had to be replaced compared to only 1% of the original block. Due to the complexity of the design, which included radii that ranged from 9m (29.5 ft.) to 180m (590 ft.), 15,000 of the 80,000 blocks used were individually cut to ensure that the many wall curves were perfectly smooth.

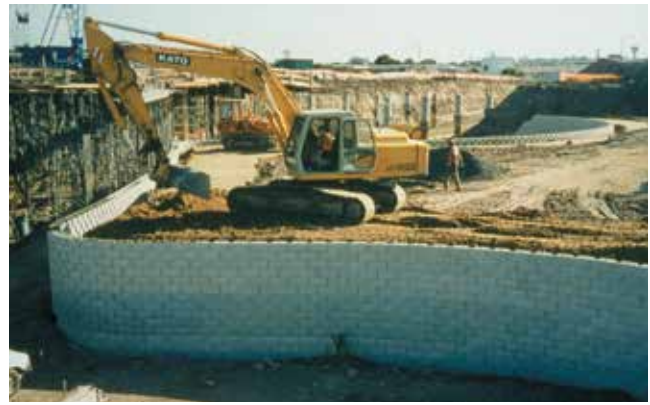
Keystone offers durable structure with flexible design capabilities

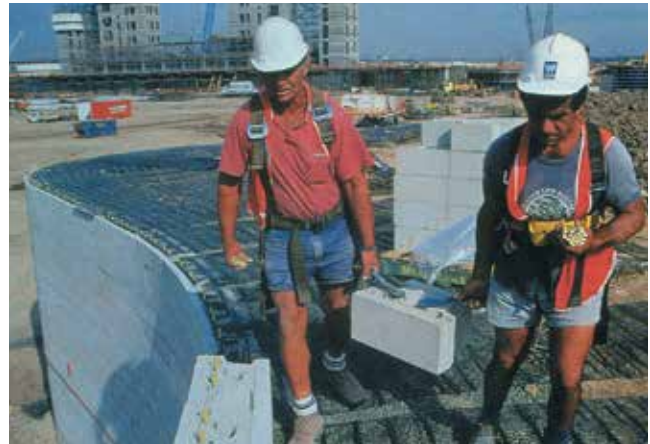
Construction continues with Keystone and geogrid
