## Bachelor's Gulch

Avon, Colorado

### Keystone Walls With Native Rock Facing

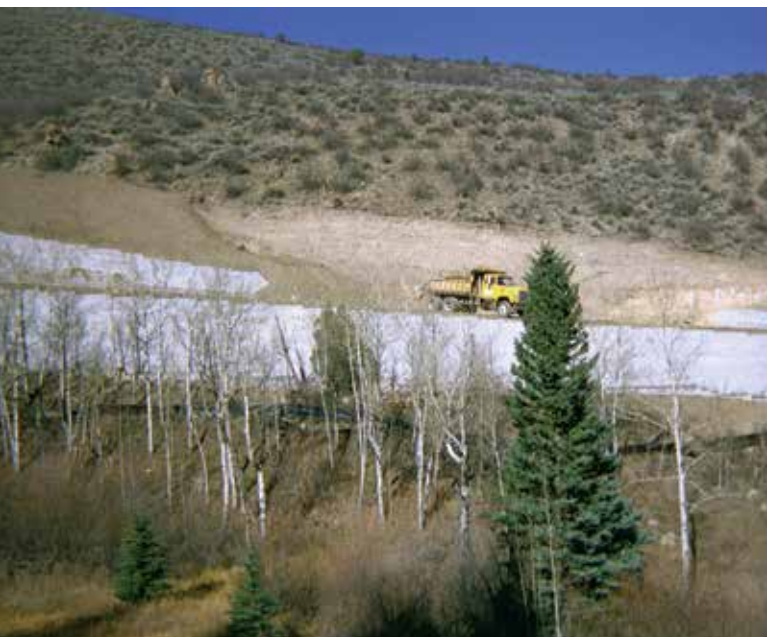
View of completed wall prior to placement of moss stone veneer.

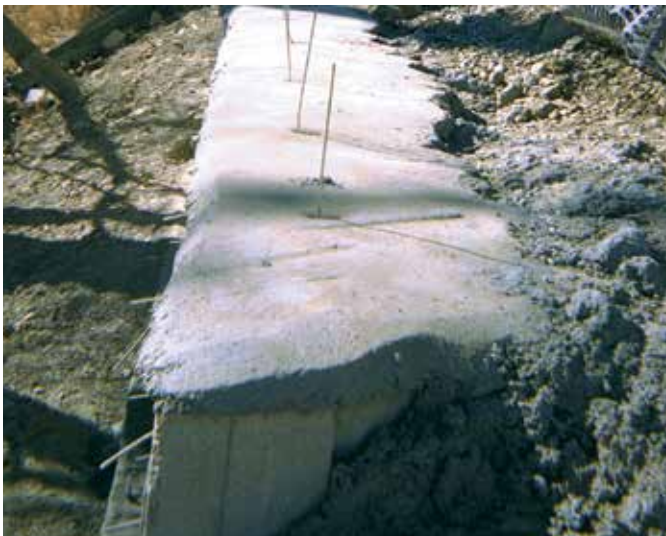
View of top of wall elevation showing grouted cap serving two purposes: (1) seal off water; (2) secure wire to units and provide clean surface for rock attachment.

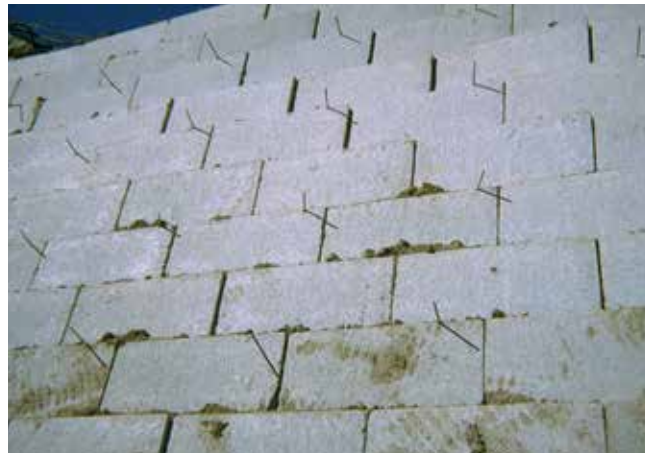
Straight face, unsplit Keystone Standard units with a 9 gauge wire provided the surface and method for attaching the rock veneer.

Modifications for attaching the rock veneer to the Keystone units were relatively simple; but because of time constraints associated with the project and the time required to adjust the mold, the individual Keystone units were modified in the field. As the units were being placed on the wall, the contractor cut a groove large enough to accommodate a 9 gauge wire tie in every unit, every other course.
